Important information

1. Software update **SET3701**
2. Diagnostic function
3. Change position of Pin 1
4. New cable **FB3702**

Because of the migration to RoHS-compliant products the board **APCI-3701** has been revised.

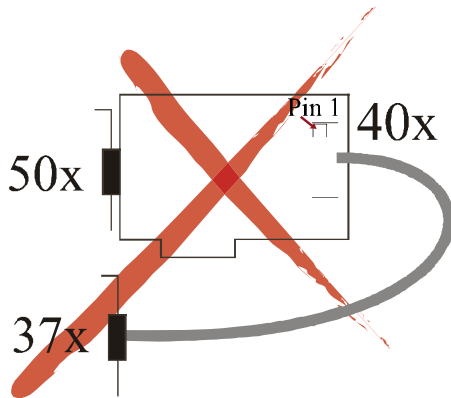
Old:

3. Position Pin 1 of the connector ST3

APCI-3701 before the change to RoHS-compliant

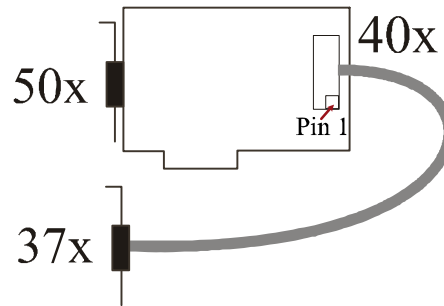
New:

APCI-3701 after the change to RoHS-compliant

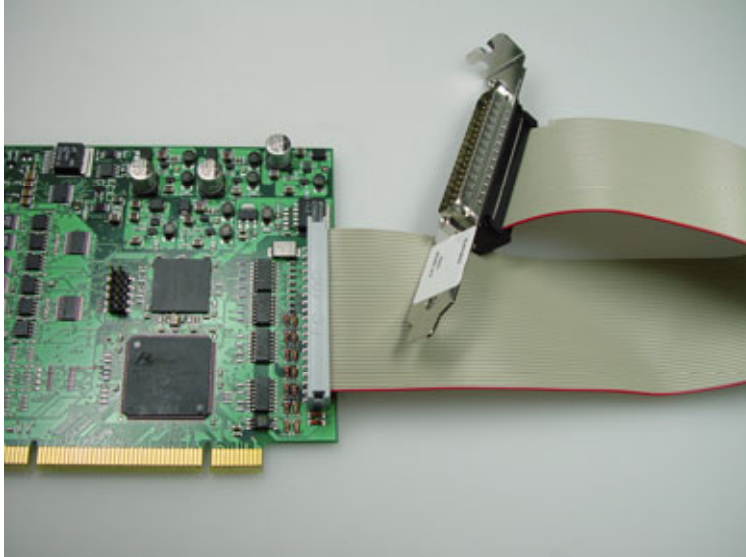
Connection new cable FB3702

The ribbon cable **FB3702** replaces the cable **FB3701**.

Should you still have a **FB3701** cable and want to use it, please do observe also the new position of Pin 1 and that the red cable line must be connected to Pin 1 (right side below). Therefore you must turn the cable. Thus, we recommend you to use the new cable **FB3702** – for an easy connection.
