Important information

1. Software update **SET3701**
2. Diagnostic function
3. Change position of Pin 1
4. New cable **FB3702**

Because of the migration to RoHS-compliant products the board **APCI-3701** has been revised.

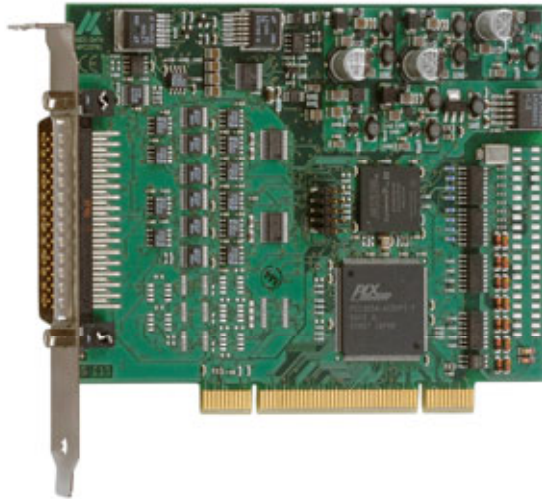
The photo shows a new **APCI-3701**.

i Because of the migration to RoHS-compliant ADDI-DATA products, the board **APCI-3701** has been revised. Thus, it is necessary to **update** the software!

Please observe that you must use the calibration and update tool **SET3701** from **version 3030-1006** for the new board. Please find the current version of **SET3701** on the delivered CD.

If you replace an old board by a new **APCI-3701**:
Uninstall the old version of **SET3701** and install the new version of **SET3701**.
